# ELECTRICAL RESISTIVITY TOMOGRAPHY FOR GEO-ENGINEERING INVESTIGATION OF SUBSURFACE DEFECTS: A CASE STUDY OF ETIORO-AKOKO HIGHWAY, ONDO STATE, SOUTHWESTERN NIGERIA

**Key words:** electrical resistivity tomography (ERT), geo-engineering, deep weathered troughs, multiple fractures, pavement failure, highway, Etioro-Akoko

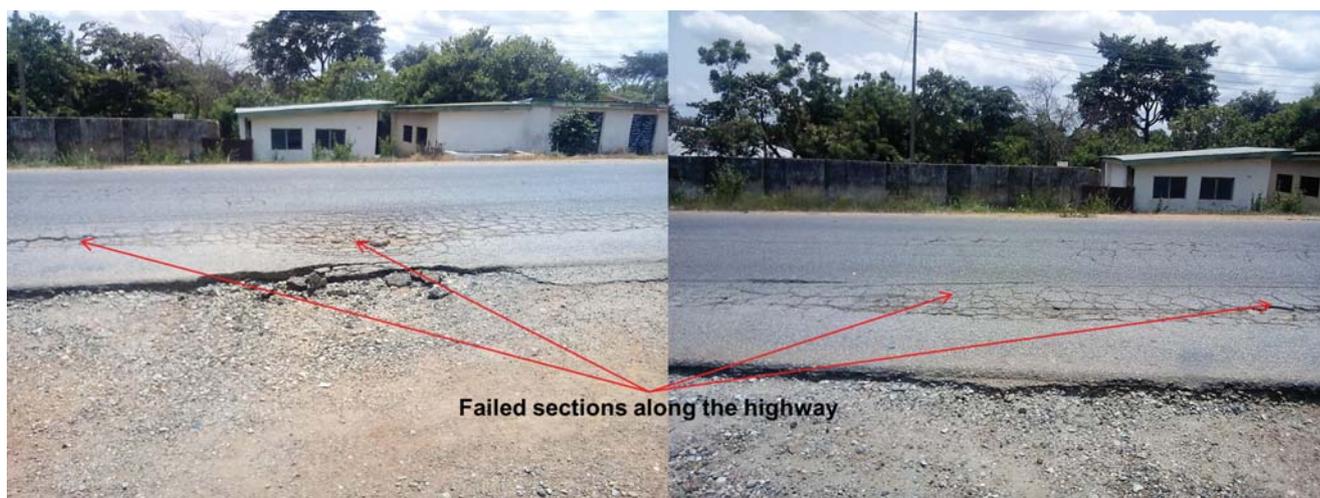
Fig. 2. Parts of failed sections along the highway in the study area.

The highway segment investigated is the failed segments in Etioro-Akoko community along Owo – Oba-Akoko – Akungba – Ikare-Akoko highway (Fig. 2). The highway constitutes one of the busiest major highways in Akoko areas of Ondo State. It runs through the study area and divides it into approximately two halves. Akingboye *et al.* (2019) reported in the study conducted in the study area that the depth of near surface strata to the bedrock is generally thin except for few places with localised depressions/troughs.

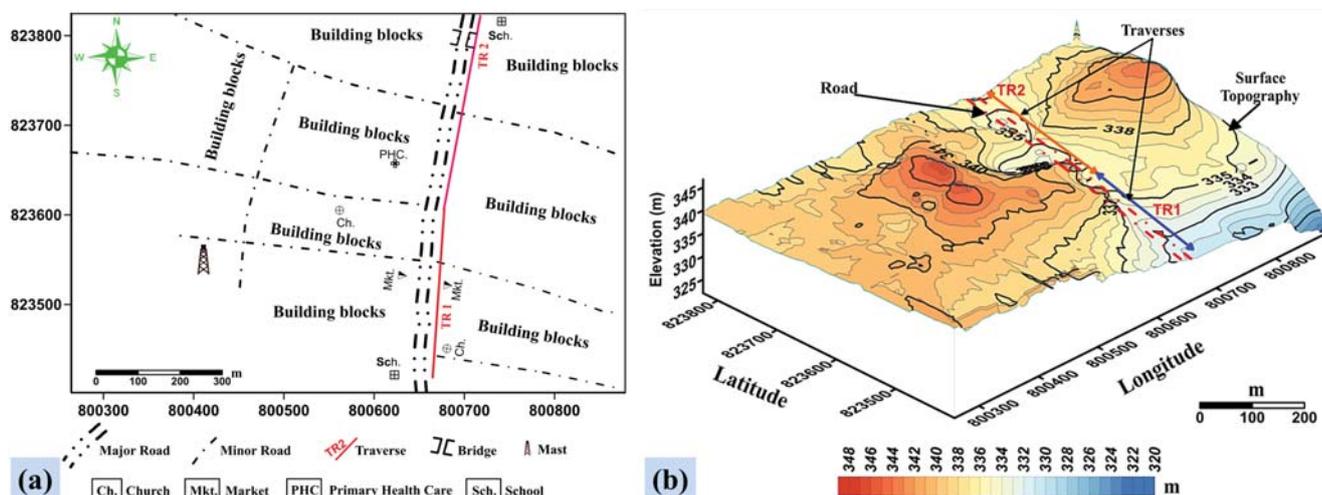
Fig. 3. (a) Data acquisition map of the study area showing the geophysical traverses (TRs 1 and 2). (b) 3D topographic map of the study area showing the surface topographic relief and the two investigated traverses (TRs 1 and 2) in NS direction at the eastern shoulder of the highway.

Measurements were acquired along two traverses (TRs 1 and 2) in the study area (Fig. 3a and b). TRs 1 and 2 were established approximately in NS direction along the shoulder of the highway to cover a total spread length of 400 m, with a spacing of 5 m between respective electrodes. A single traverse of 200 m each without a roll-along technique was employed to enhance signal-to-noise ratio and for better vertical resolution profile without smeared structures from artifacts. This practice was adopted because of the nature and complexity of the subsurface geology of the area, and reduction in amount of penetrating current due to increasing electrode distance and probing depths. Usually, the depth of road pavement rarely exceeds the first near surface strata; therefore, smaller electrode spacing is usually required for such investigation. To achieve this, cell widths of half electrode spacing in the inversion software was employed to derive half of the unit electrode spacing for the 2D resistivity models.

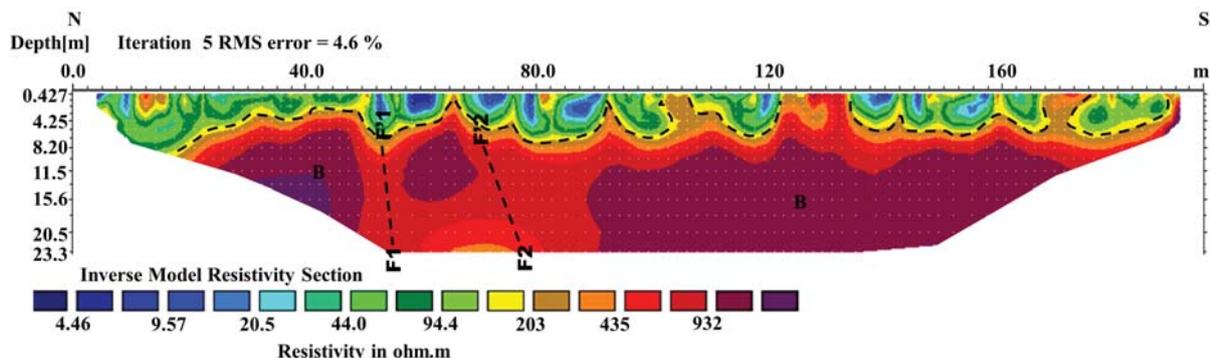
Fig. 4. 2D inverse model resistivity section of traverse 1. The subsurface geology is characterised by thin overburden which is underlain by gentle oscillating bedrock surfaces separated by an extensive partially weathered/fractured bedrock zone produced from two contemporaneous fracture systems (F1–F'1 and F2–F'2). The black broken lines with varying amplitudes mark the surface of the weathered bedrock.

The subsurface inverse model resistivity section of TR 1 is shown in Fig. 4. The inverse resistivity model is charac-

terised by four distinct subsurface layers of varying resistivity responses. The first layer is characterised by surficial clayey topsoil with resistivity generally below 150 ohm-m and depth extent of about 2 m. The topsoil is interspersed by discontinuous pockets of highly resistive material denoted as lateritic/hard-pan clay in few places. The second layer is characterised by constituents of the weathered materials typically of saturated clayey sand/sandy clay, with resistivity ranging from 10–203 ohm-m and thickness ranging from 0.5–11.5 m at stations 105 m and 15 m, respectively. This layer is discontinued by a third layer, which is the partially weathered/fractured bedrock, with resistivity response in the range of 205–700 ohm-m and depth greater than 25 m. The third layer peaks to the near top layer at stations 65 m, 105 m, 122–132 m and 170 m, giving the weathered layer a curve to lenticular shapes particularly from station 170 m to the end of the traverse.

Stations 47–55 m and 60–85 m witnessed two contemporaneous multiple fractures: F1–F'1 and F2–F'2, respectively. These are partially inclined deep penetrating fractures with similar trending direction. F2–F'2 is a late phase fracture, which further fractured and displaced the earlier fractured bedrock by F1–F'1 downwardly, leaving a leaning-fractured resistive bedrock within. This leaning bedrock slab was later weathered due to infiltrating soil water and seepages from beneath to form a resistive boulder as floater at depth range of 5–15 m. An arc-like structure was also formed at its base arising from the resultant effect of continuous weathering. The fresh bedrock (B), the basal unit, depicts resistivity that is generally greater than 1000 ohm-m. The fresh bedrock is characterised by axial planes dipping in the direction of the fractures around stations 45 m and 87 m, and gentle undulating surface. It is segmented into northern and southern sections by the extensive partially weathered/fractured zone.

The two inverse model resistivity sections (Figs. 4 and 5) show four distinct subsurface layers. The shallow clayey topsoil, uppermost layer, is characterised by resistivity generally less than 150 ohm-m and thickness value of about 2 m. The saturated clayey to sandy weathered layer (second layer) has resistivity and thickness values in the range of 10–325 ohm-m and 0.5–12.5 m, respectively. The partially weathered/fractured bedrock, third layer, depicts resistivity values ranging from 205–800 ohm-m and thickness ranging from the near surface to greater than 24 m. The fresh bedrock is characterised by resistivity generally in excess of 1000 ohm-m.

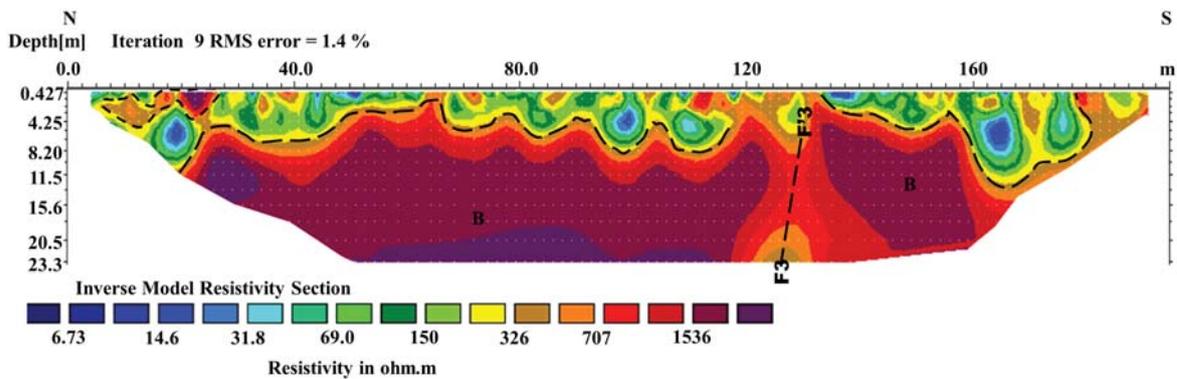
**Fig. 5.** 2D inverse model resistivity section of traverse 2. The deep penetrating fracture (F3 - F'3) discontinued the consistently high resistivity bedrock to produce a conductive pathway for water.

The inverse model resistivity section of TR 2 presented as Fig. 5 shows similar features in terms of overburden and underlying bedrock characteristics to that observed in TR 1. The inverse model shows four distinct subsurface layers of varying resistivity responses. The topsoil with resistivity response pattern generally below 150 ohm-m is interspersed by discontinuous multiple pockets of resistive lateritic/hard-pan clay. This response pattern extends to depth of about 1.9

m. The second layer, weathered layer, is characterised by resistivity and thickness ranging from 10–325 ohm-m and 0.5–12.5 m, respectively. This layer consists of weathered bedrock materials typically of clay to sandy soil compositions with water saturation. The bedrock underlying the weathered layer is marked by relatively gentle to rapid oscillating partially weathered surfaces and fracture. These two features formed the third layer, which is the partially weathered/fractured bedrock with resistivity values in the range of 330–800 ohm-m. The fourth layer is the fresh bedrock (B) with resistivity generally in excess of 1000 ohm-m.

The bedrock topography along this traverse mirrored deep and elongated bedrock troughs between stations 12–23 m, 32–44 m and 156–178 m. At near surface depth, the foundation floor of the existing bridge between stations 19 m and 22 m is mapped to be resting on fairly weathered to resistive thin bedrock. Stations 70–110 m are zones with continuously oscillating and increasing bedrock depressions. Within stations 122 m and 135 m, an X-shaped structure produced by fracture (F3–F'3), is envisaged. This fracture segmented the bedrock into two: wide bedrock

unit extending from station 120 m to extreme northern end, and tooth-like shape bedrock with partially weathered base at the southern section.

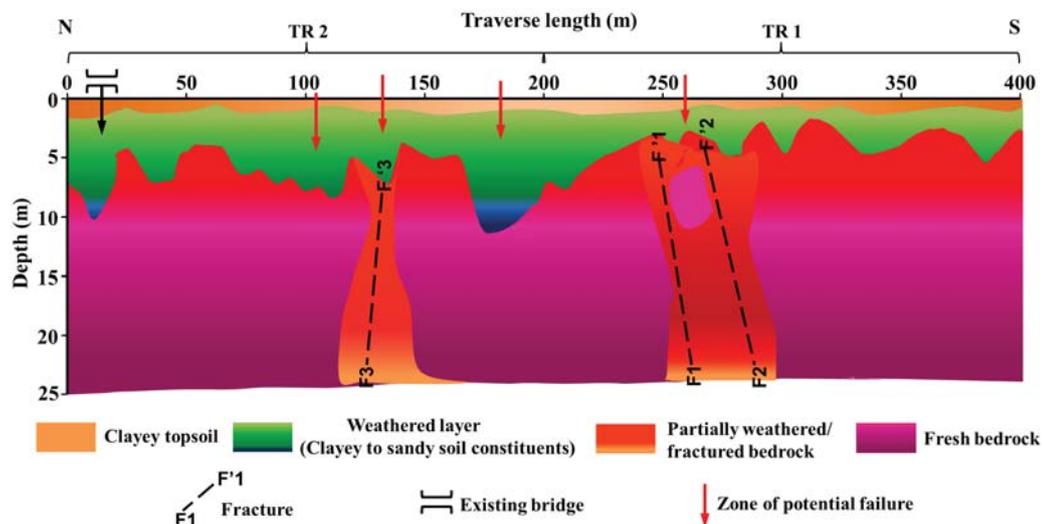
**Fig. 6.** Litho-section of the total traversed length along the Etioro-Akoko highway. The image shows the nature and thicknesses of the topsoil and weathered layer. The gentle to rapid undulating bedrock topography which is occasioned by deeply weathered and elongated troughs, and the fractured bedrock and zones of potential failures along the highway are also clearly imaged.

Figure 6 shows the subsurface litho-section underlying the investigated segments along the highway in the study

area. It shows that the overburden covers are generally less than 4 m, except for few places with deep weathered and elongated bedrock troughs extending to depth of about 15 m. The bedrock underlying the road is characterised by three deep penetrating fractures: F1–F'1, F2–F'2 and F3–F'3, trending in two major directions, and gently to rapidly oscillating topography. F1–F'1 and F2–F'2 are in opposite direction to F3–F'3 with approximately the same angle of displacements. These fracture systems compartmentalised the fresh bedrock into three segments: northern flank segment extending to station 120 m, stations 135–248 m segment, and southern flank segment extending from station 290 m. The fractured zones within the compartmentalised bedrock and deep bedrock troughs are possible conduits for groundwater/seepage zones along the investigated road segment. These major features are inimical to the substrate of the highway. The highway situation is further compounded by the clayey nature of the first two near surface strata. This nature is suggestive of a constant swelling and shrinking potentials of the sub-base/substrate materials that subsequently cracks the pavement of the road.

Along the deeply weathered and elongated bedrock troughs, possibilities of potholes are imminent. Both the constant vibrations from heavy traffics and declining bearing capacity of the floaters (boulders) and fractured bedrock may have provoked differential settlement and consequent failures of road sections in the area.
