**EXAMINATION OF COIL PIPE BUTT JOINT MADE OF 7CrMoVTiB10 – 10(T24) STEEL AFTER SERVICE****BADANIE PODCZAS REMONTU ZŁĄCZY DOCZOŁOWYCH RUR WYKONANYCH ZE STALI 7CrMoVTiB10 – 10(T24)**

The paper presents the results of examination of coil pipe butt joint made of 7CrMoVTiB10-10 steel (T24). Tested joint was in service for approximately 12 000 hours at the temperature of 540°C and pressure of 5.48MPa. Tests have revealed that the structure of all regions of the homogenous welded joint are correct and without any welding imperfections. Operation of the weld contributed mainly to advantaged precipitation of carbides especially on grain boundaries – frequently in the contact area of three grains' boundaries as well as in the form of continuous network of precipitates. The measurement showed high hardness of the weld, what indicates high stability of the microstructure. It makes possible to find that post-weld heat treatment is indispensable.

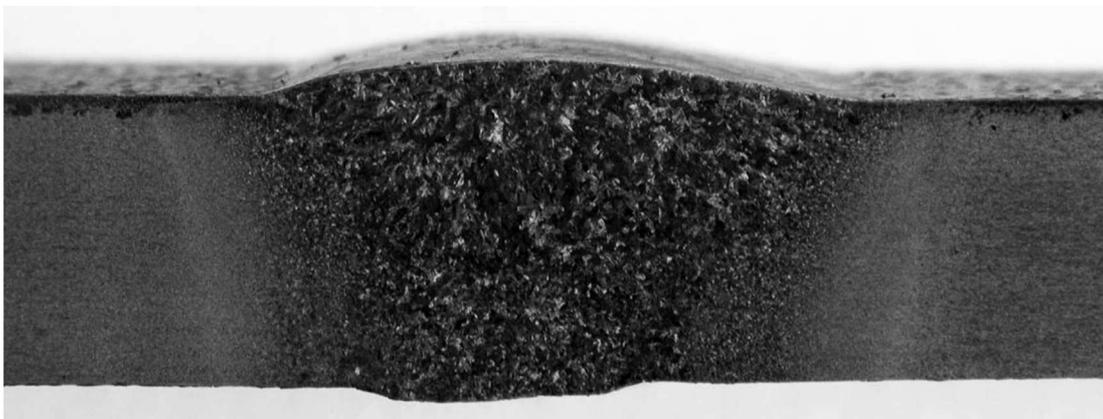
Fig. 1. Macrostructure of a welded joint, Nital etching, magnification ~6x

Macroscopic and microscopic examination was performed in accordance with PN-EN 1321 standard [6]. The examination has revealed that the shape of a weld is correct and without any welding imperfections. Macrostructure of the welded joint is shown in Fig. 1.

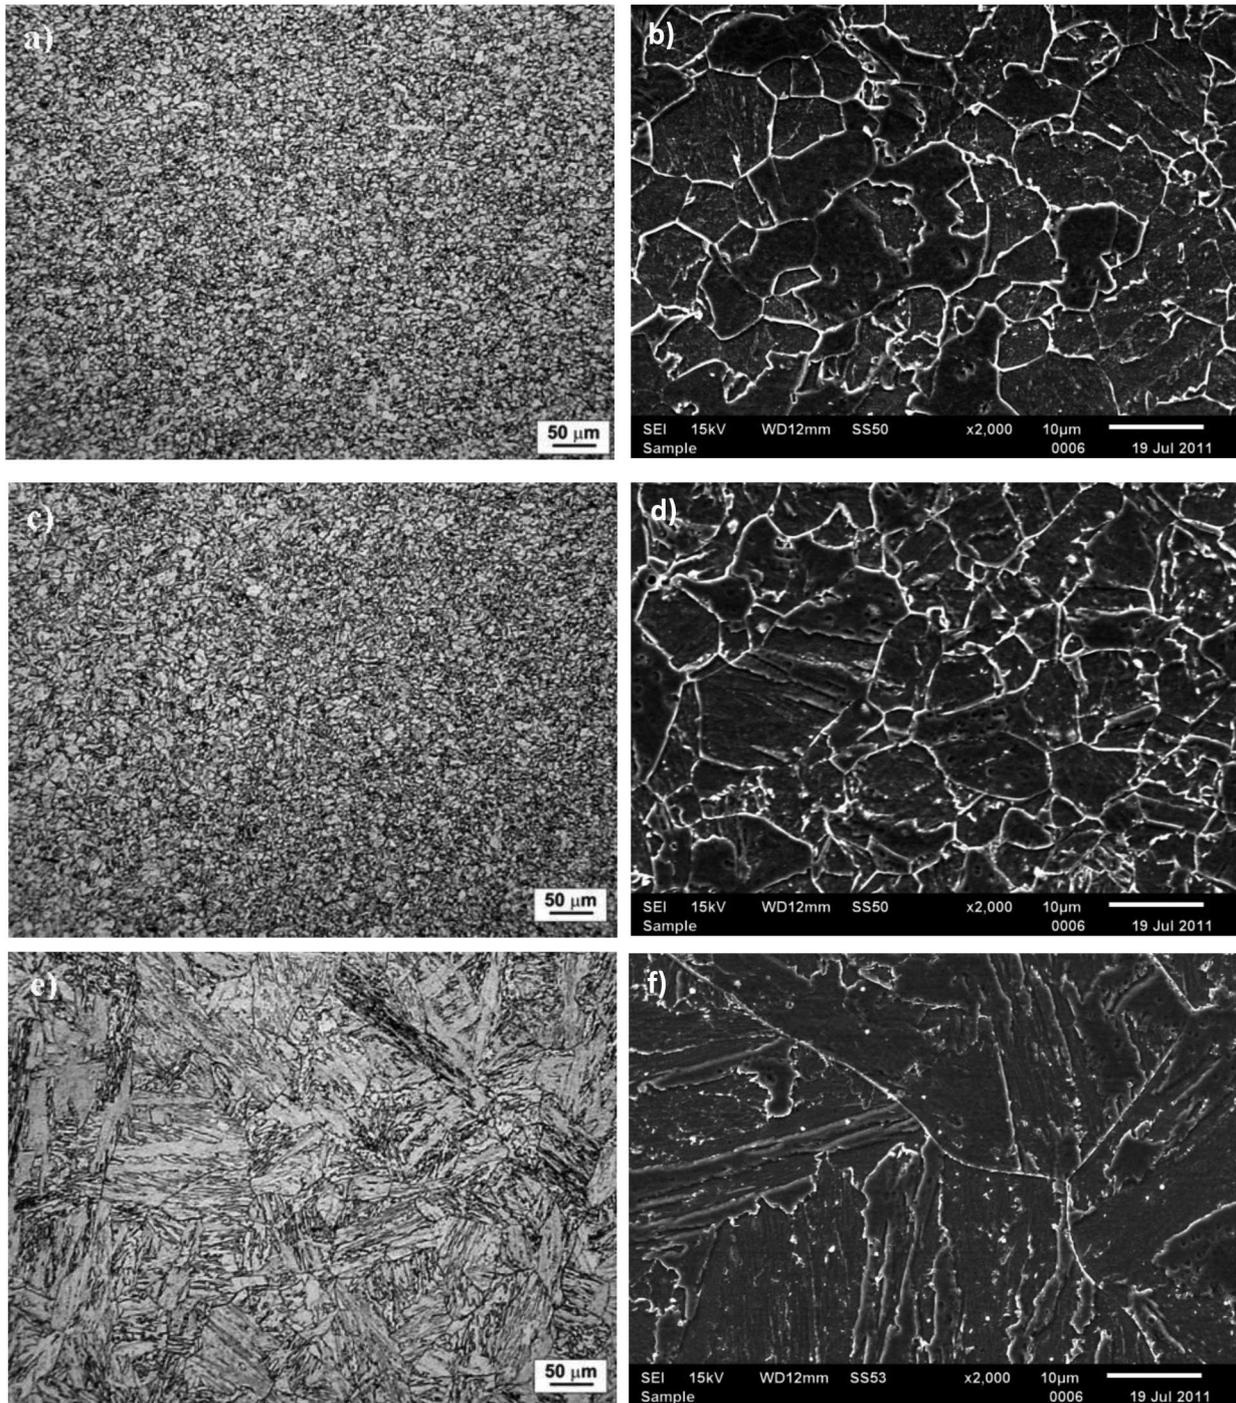
Fig. 2. Microstructure of homogenous joint in steel T24: a, b) parent metal; c, d) heat affected zone; e, f) weld, nital etching, OM, SEM

Microstructural examination has failed to reveal microcracking as well as confirmed the correct microstructure in all regions of the homogenous welded joint. The examinations of the welded joint microstructure were performed in all regions of the welded joint (Fig. 2). Parent metal – steel T24 had a fine-grained bainitic microstructure (Fig. 2a, 2b). According to the research [7] this microstructure is the most desirable microstructure of T24 steel in the initial state (subsequent to heat treatment) in the case of production of homogenous welded joints. On grain boundaries in parent material isolated large, approximately 1µm carbides (frequently precipitated in the contact area of three grains' boundaries) have been revealed. So called continuous network of precipitates on boundaries have been observed as well. Grain size determined basing on diagram examples [8] for parent material was 9.5; which corresponds to average grain diameter of 13.1µm. In the welded joint lower bainite microstructure was found (or a mixture of lower bainite with martensite) with numerous carbides of various sizes, precipitated both on prior austenite grain bounda-

ries, bainite banding boundaries and inside the grains (Fig. 2c ÷ 2f). It should be noted that in the heat affected zone which was heated while welding to the temperature corresponding the diphas range  $A_{c1} - A_{c3}$ , the partial transition of bainite to austenite occurs, which results in creation of “fresh” austenite while cooling. Research [9] has revealed that decohesion of the joint takes place most often in the region heated up to the intergranular temperature  $A_{c1} - A_{c3}$ .

Microstructure of lower bainite (or a mixture of lower bainite and martensite) of a weld and lower bainite in the heat affected zone contribute to the creation of high internal stresses for which lack of postweld heat treatment – stress relief annealing – creates favourable conditions. This microstructure results in achieving high hardness between separate weld zones but simultaneously it causes the increase in temperature of brittle transition to the temperature above zero [7, 10]. In the

joint area, like in parent metal, large isolated carbides occurred on grain boundaries as well as continuous network of precipitates was observed. The joint, compared to parent metal, was characterised by various grain sizes; according to standard scale from 10 (in normalised region) through 7/8 to 4 for a weld (the region heated up to temperature  $A_4$ ) which correspond to the average grain diameters of 11; 31.2/22.1 and 88.4  $\mu\text{m}$  respectively. The grain size in acicular structures is of the essential importance, as fine grain not only improves opposing properties, i.e. yield point and impact resistance, reduces temperature of brittle transition but according to research [11] influences also the improvement of creep strength. Precipitation processes in discussed regions were more intense on prior austenite grain boundaries and bainite banding boundaries than inside the grains. Advantaged precipitation processes on grain boundaries and related reduction of chromium and especially molybdenum and carbon in the matrix result not only in the decrease in solid solution strengthening but also they can contribute to the improvement of phosphorus concentration in the region near the boundary. Literature data reveal that in steel T24 while creeping process there is the carbide  $M_6C$  precipitation [12] on the grain boundaries at the expense of carbides  $M_{23}C_6$  which also precipitate on the grain boundaries as well as MC type precipitations are enriched with molybdenum [13]. The precipitation and growth of the carbides  $M_6C$  leads to the reduction of chromium in the matrix what results in reduction of solid solution strengthening and consequently in the recovery and recrystallisation of the matrix. The enrichment of MC carbides with molybdenum makes possible the nucleation on the interface boundary of MC carbide/acicular ferrite of  $M_2C$  type precipitations [14]. Above mentioned complexes created at the expense of MC carbides are referred to as „H – carbides” and may lead to the decrease in creep resistance of materials. Similar phenomenon has been observed in high-chromium steel designed for power generation industry where at the expense of fine-dispersed precipitations of MX type the complex nitride – Z phase is created. The Z phase formation contributes to the rapid decrease of creep resistance of those steels [15].

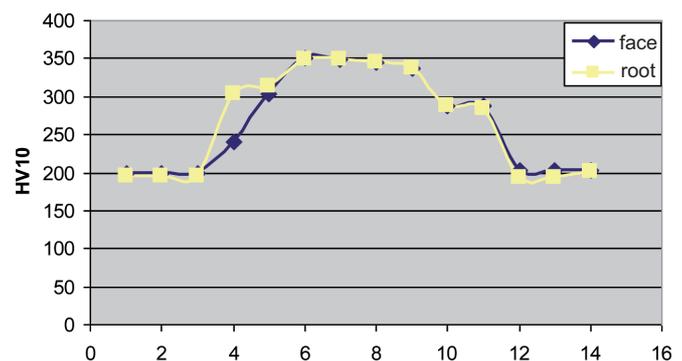
Fig. 3. Results of hardness measurement for tested joint

Hardness measurement was conducted in accordance with PN-EN 1043-1 [18] and PN-EN ISO 6507-1 standards [19]. Hardness was measured along two lines, approximately 2 mm from the upper surface of a weld face and approximately 2 mm from the lower surface of a weld root. The obtained results of hardness measurements are shown in Fig. 3. The measurements have revealed that average hardness for parent metal is approximately 202HV10, for HAZ – 287÷314HV10 and 348HV10 for a weld. Assuming the maximum hardness of 350HV10 for this material (joints in bainitic steel, no post-weld heat treatment) it was found that all obtained hardness results are lower than the acceptable ones. Simultaneously the hardness measurements of welded joint are comparable with those for homogenous joint in steel T24 prior to service (as welded, no heat treatment) [2, 5, 10].

This indicates high stability of the microstructure of the tested steel and proves literature data [20, 21, 22] which reveal slower decrease in the mechanical properties compared to impact resistance during the service. Moreover high hardness of a weld after service and literature data [4, 18, 22] which show little decrease in the mechanical properties during the service make possible to find in a justified way that post-weld heat treatment is necessary in the case of those steels. Especially high yield point and tensile strength may correspond also to high hardness of a joint, what for low plasticity may favour cracking of a joint.
